## REPORT

**REPORT NO.:** CL-2008-0051

**RE:** Consideration for Designation of Fallbrook Farm (formerly known as Beecham House) under Section IV of the **Ontario Heritage Act**, 14513 27 Side Road, Con 9, Lot 28. File No.: R01 FA

### McClure Log House (Fallbrook Conservation Area) Heritage Investigation Report

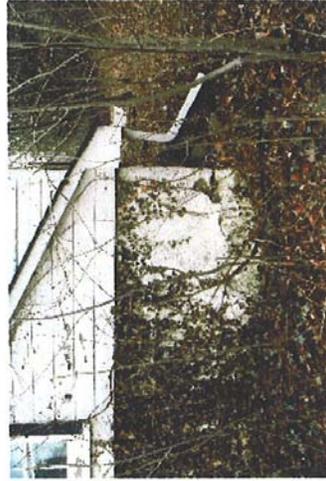
8. Close up of the utility/cold cellar wall. Plaster on stone.

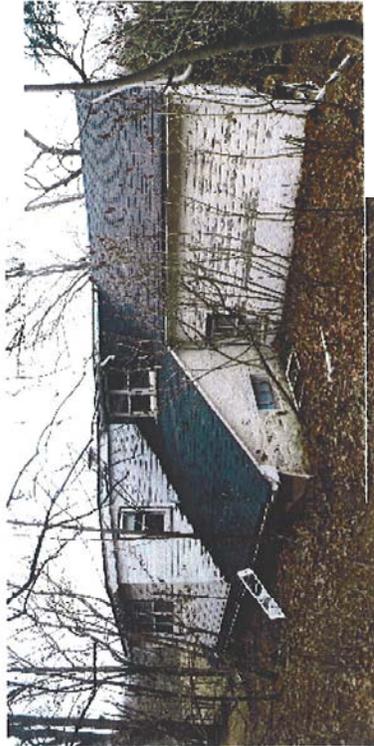
9. The back of the house is partly built into the hillside. The cold cellar is an early addition and the large dormer is probably somewhat later.

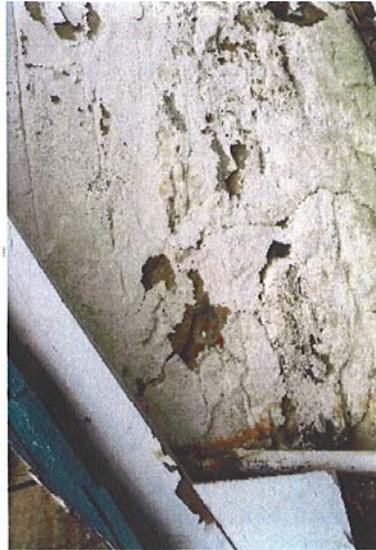
10. Close-up of the cold cellar wall showing a relatively thick layer of plaster over rubble stone. The plaster has a reddish colour indicating a local sand was used.

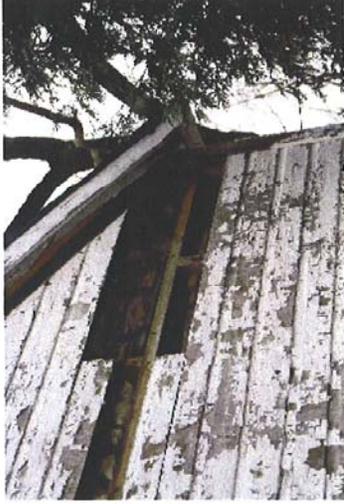
12. Damage at the eaves shows heavy applications of mortar and rubble. Logs are not clearly evident.

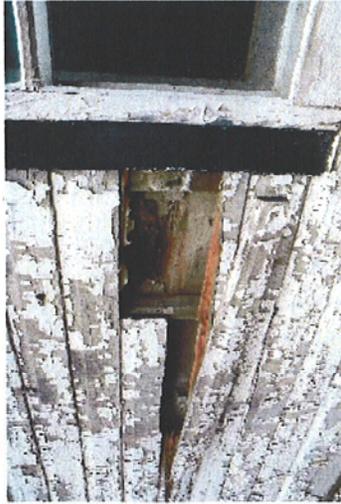
13. The sawn log construction is clearly visible where the siding has been broken. The strapping is old wood indicating that the logs may have had siding added at an early date.

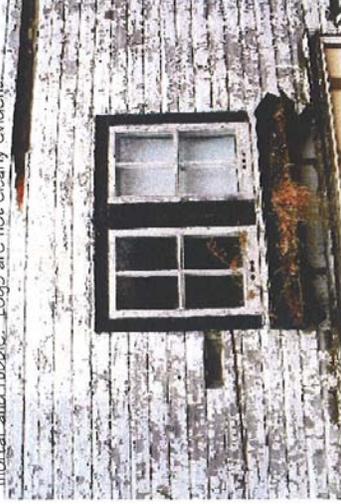
14. Close up of windows and hole in siding where photo 13 was taken.

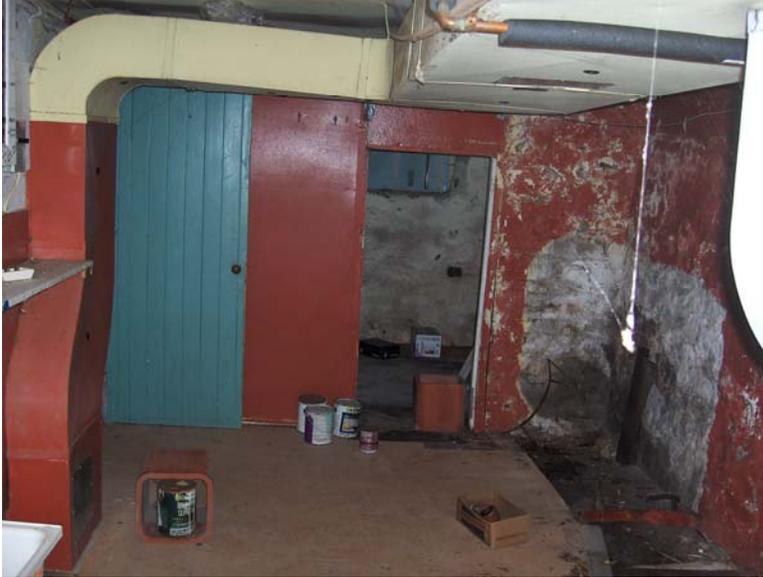
**1.14 View west inside the earth embanked, utility room** Blue door, left into kitchen. The stone wall (right side) is almost completely below grade. This stone addition may have been a very early addition to the house, constructed to deal with the chronic damp from snow and leaves against the north wall of the log house. In fact, the lower log course and exterior siding (just beyond the root cellar) was replaced by the C.V.C. approximately seven years ago. The slope of the hillside towards the house and the damp conditions on this north west corner have probably been of concern since the house was first built.

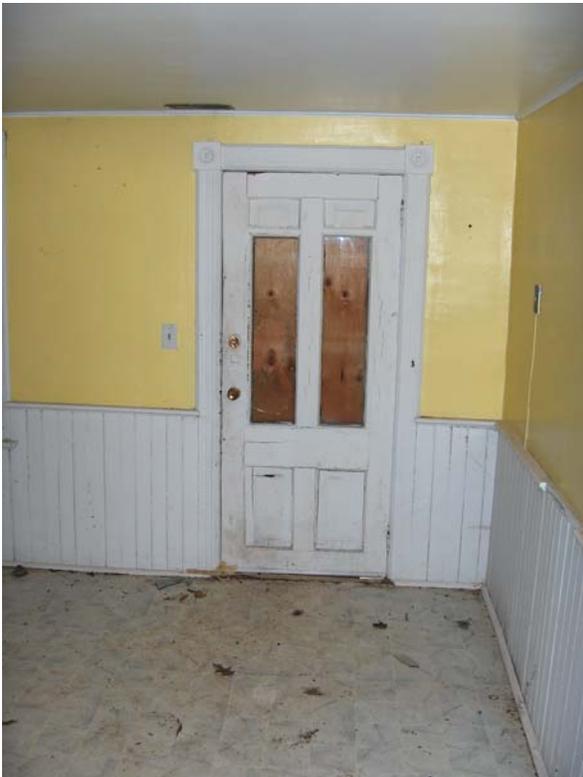
**1.15 Kitchen door /South Elevation.** Note tongue and groove wainscot with simple bullnose chair rail at 33" above floor. The plaster and lathe were installed after the chair rail and were finished onto the top of the rail, ensuring a solid and durable finish. This

1.16 The six panel door has been modified to accommodate two window panes. The modification was done very poorly, leaving almost none of the upper style and requiring filler pieces on the sides of the heavy plate glass to fit the rails. The door also appears to be cut down on the bottom rail, perhaps indicating that the floor is higher than originally constructed. This may mean that at least one more layer of floor boards were added above the original pine flooring. The ceiling is also a little too smooth for a plaster ceiling of this age. It has either been repaired by a competent plasterer, or covered with drywall and refinished. Adding finish over the original ceiling might explain the narrow gap between top of the door trim and the ceiling.

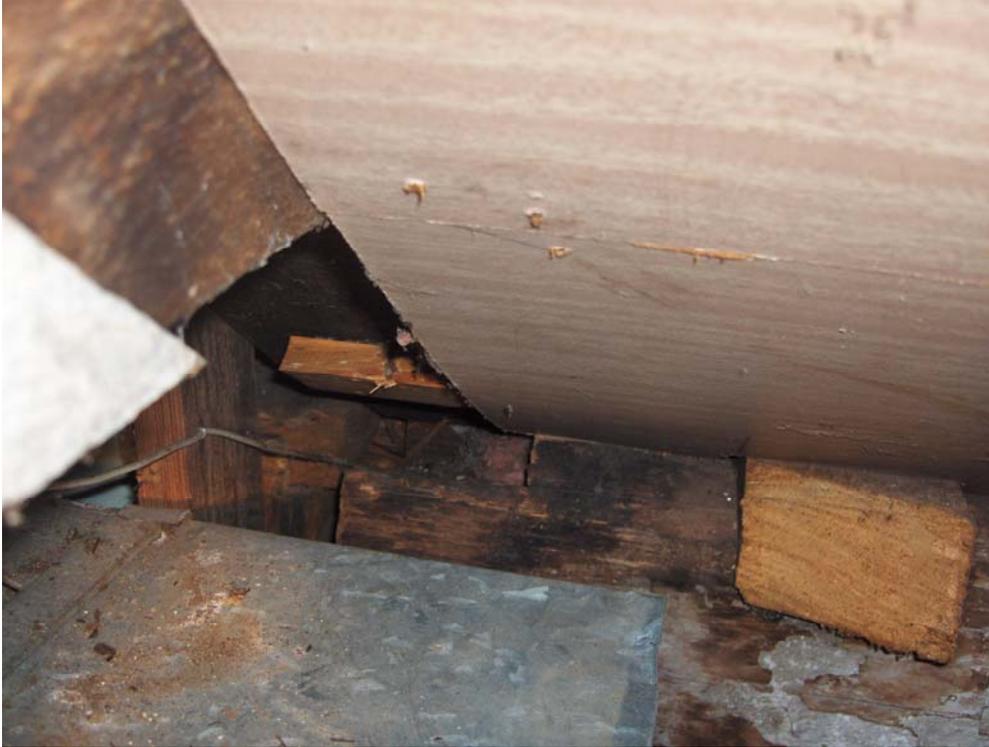
**1.29 Timber top plate** with portion of sawn top plate from adjoining addition visible under paneling (just below end of 1" sheathing that has been sawn off. Note also, the notch in the 8" log forming the top plate to support the rafters, and the sawn 3" x 4" piece that may have been used as a girt or tie beam for the log gable. The rafter tails were birdsmouthed in the typical way, but were stepped more than 5" into the log requiring a deep notch. It was more typical for the birdsmouth to be seated on a 1" notch chopped into the inner face of the log with a hatchet or broad axe. This method of roof construction and shallow pitch (approximately 5/12 are typical of the 1830-50 period.

The sawn off 3" x 4" pine girt is a novelty however. The purpose of this piece is probably as a tie between the top plates across the house. Removal of the ceiling would be necessary to see if it has a dovetail connection to the timber, but it seemed to be installed tightly into the plate.

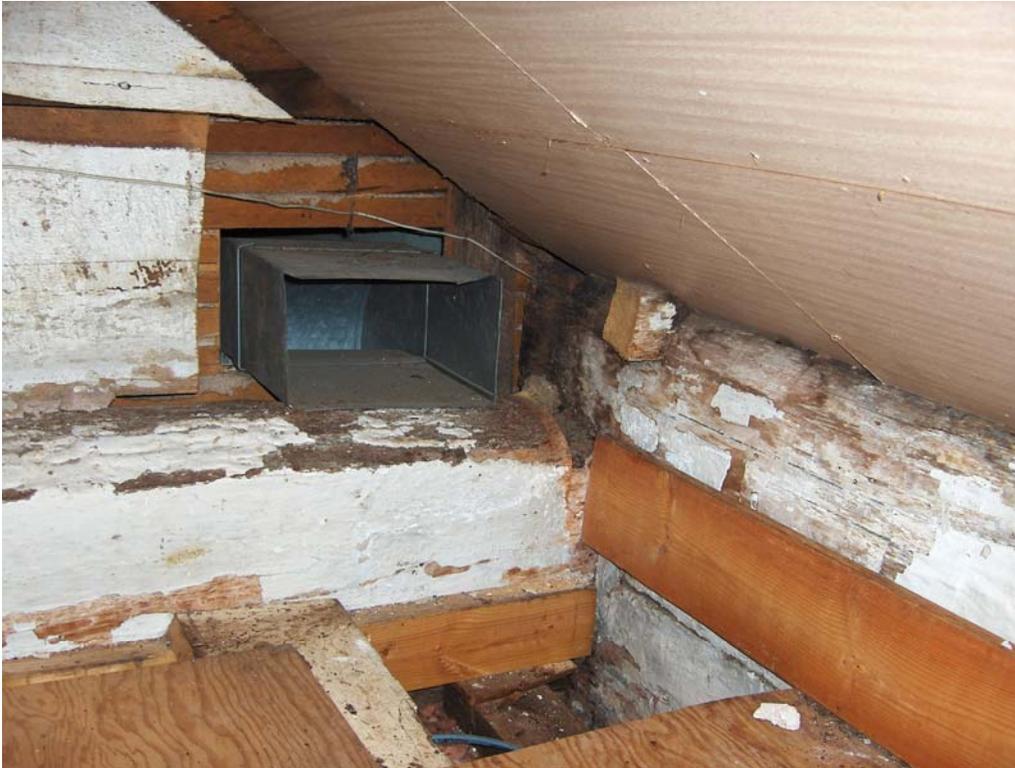
**1.42 Interior of McClure/McKay Log House, at top plate. Notice whitewash on logs and interior of gable frame wall. (Pine board on the right side and plywood flooring are modern). The whitewash flakes off in thick chips with visible layers indicating several applications of the mixture, applied over many years of use. © T.Murison 2008**

1.43 The presence of whitewash applied to all the attic surfaces, indicates that this space was in use as habitable space, probably as a bedroom. The bark is also visible on the log just below the modern duct. Sawn lathe and plaster is also visible behind the duct where the frame addition was constructed on the east side of the building. The bark is deeply furrowed and bonded tightly to the wood even now, an indication that it is extremely well preserved and red pine, not white pine. There is an indication of rotation of the top log on the right side of the image (south wall) probably due to the fact that the rafter seats are not transferring load from the birdsmouth joints (at the bottom of the rafters) to the inside face of the log, but beyond the midline of the log wall. Loading the log towards the outside face causes outward rotation of the top of the log, and usually distortion or failure of the wall. The fact that the log wall has not failed strongly suggests that the top log is pegged. Further evidence of this was noted where the half-dovetail was used on the top log of the west wall to attempt to lock it in place with the penultimate log on the south wall. This is an unusual error that suggests a builder with limited experience or understanding of the structural details of this construction.

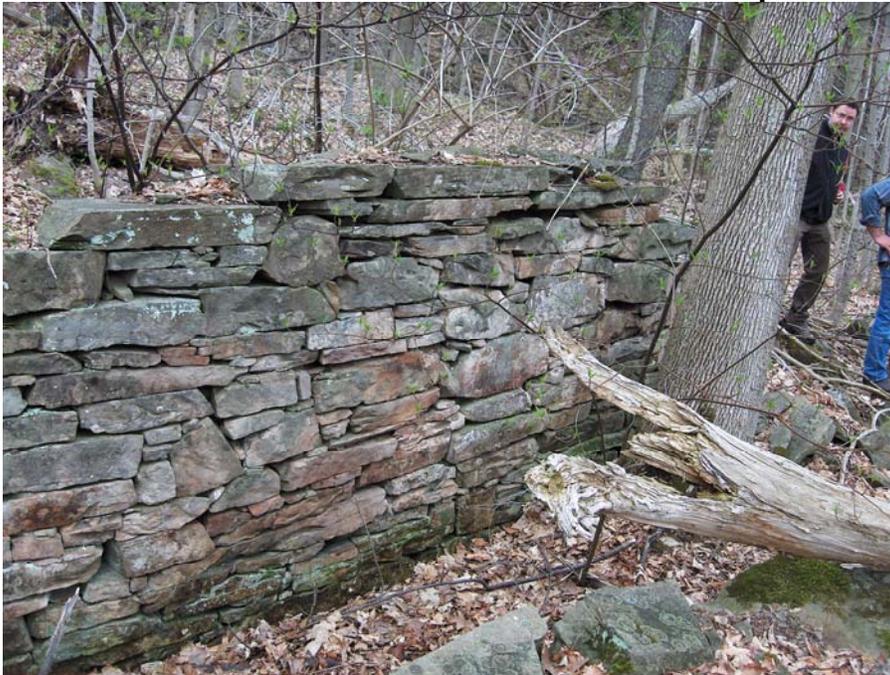
**4.17 Portion of earth embanked wall which supported bearing blocks for millwheel. Large (20") hardwood tree has grown up on the debris and stone which has filled the trench. Rob Kier (black jacket in background) a resident of the house, found these walls in 1961.**

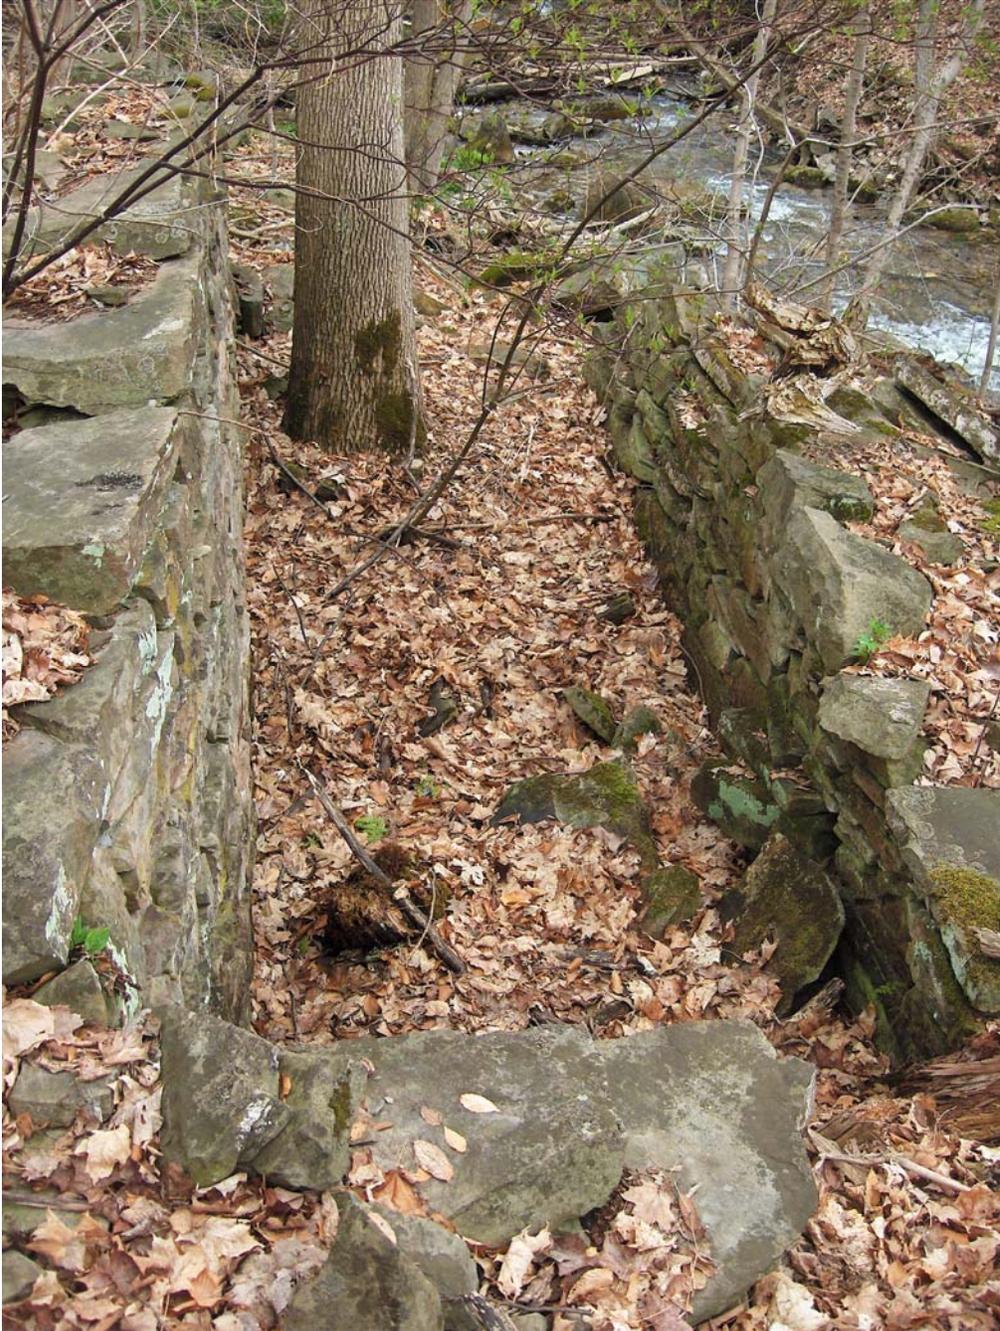
**4.18 View down into wheel pit. The west wall of the stone foundation has suffered more outward collapse, possibly due to floodwaters from the creek. It is believed to have been the same height as the east wall, so that the axle for the millwheel could be supported by both walls. The pit may extend several feet below the level of the leaves, which would create enough height for an overshoot wheel at least 14 feet in diameter and 4 feet wide. This is a large wheel which could provide approximately 25 horsepower to run a grist mill. The area to the east of the wall has several large stones that appear to be placed and leveled to carry the timbers which supported the timber framed mill building.**

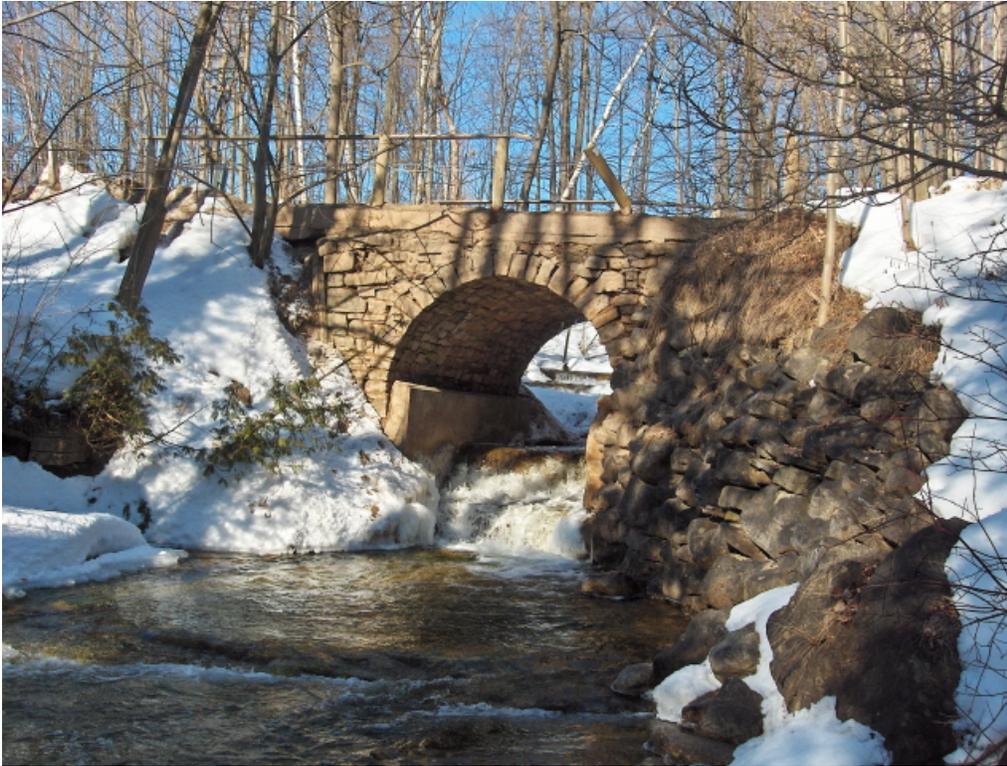
**5/06 Silver Creek Bridge (sandstone bedded in lime mortar, single vault) Note modern concrete abutments added to reinforce base of arch, and wooden railing installed on concrete cap laid over masonry. © T.Murison 2008**
